**DOT/FAA/AR-96/21**

# **Composite Failure Analysis Handbook Update 1**

**WL-TR-93-4004**

August 1997

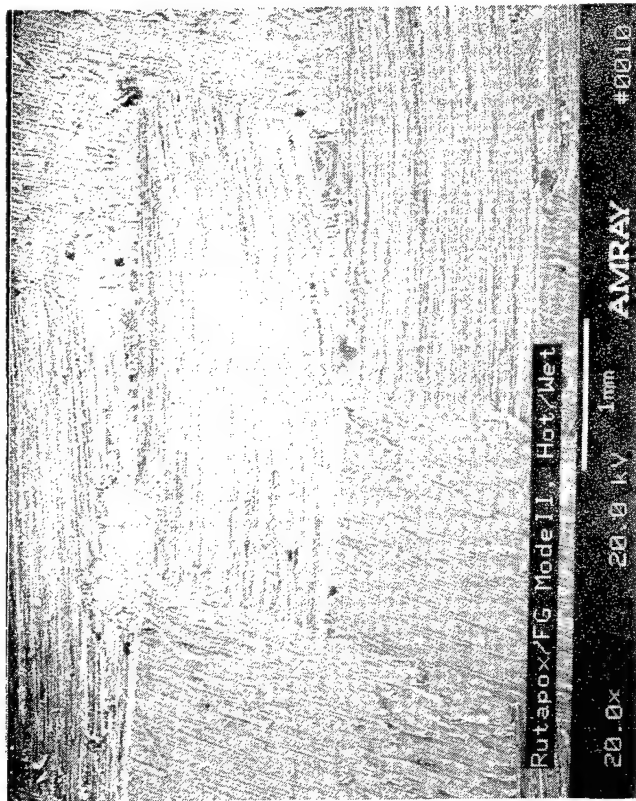
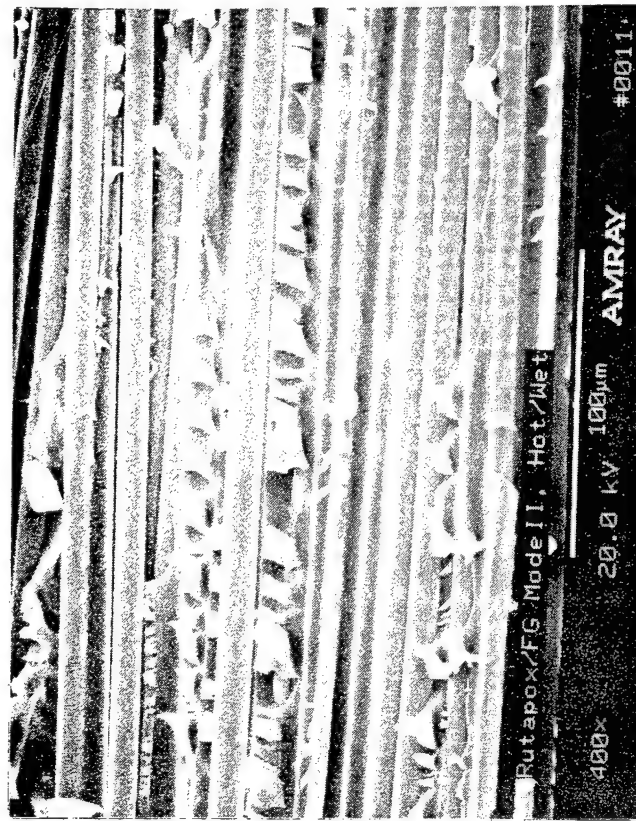
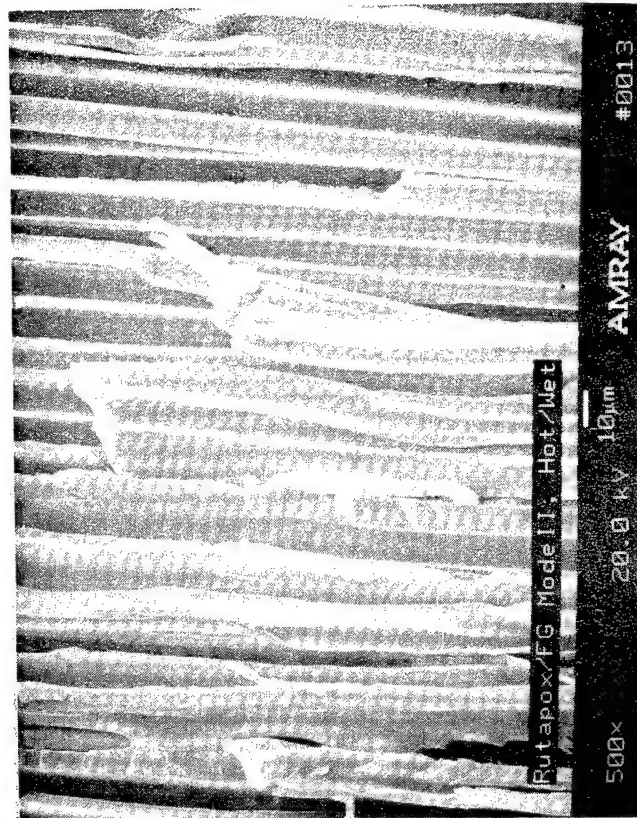
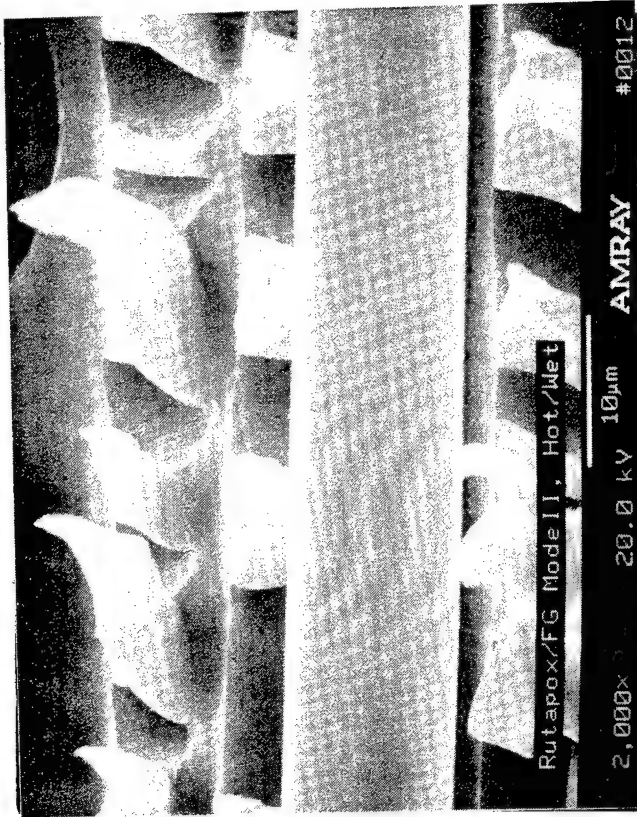
Figure 3.6-6. SEM Fractographs of a Rutapox/FG Fabric Interlaminar Mode II (Shear) Hot/Wet Fracture Surface, RT

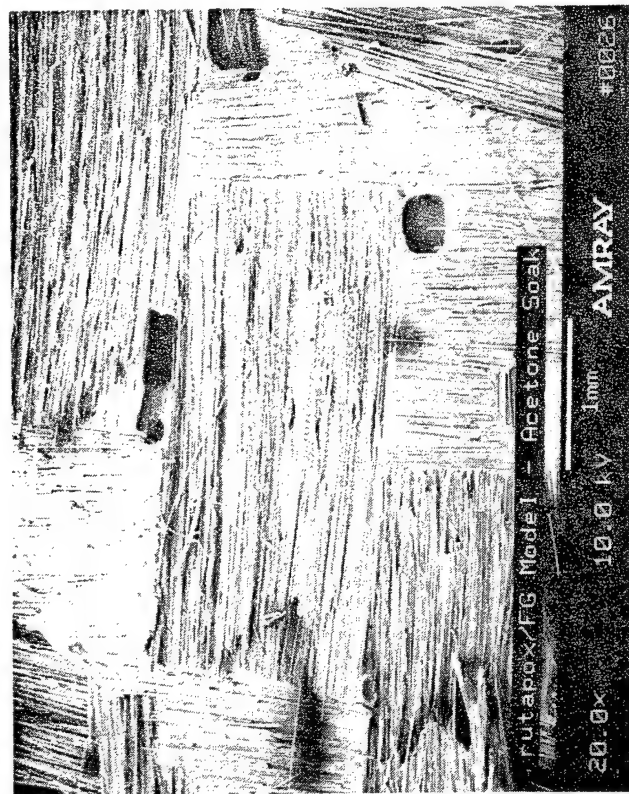
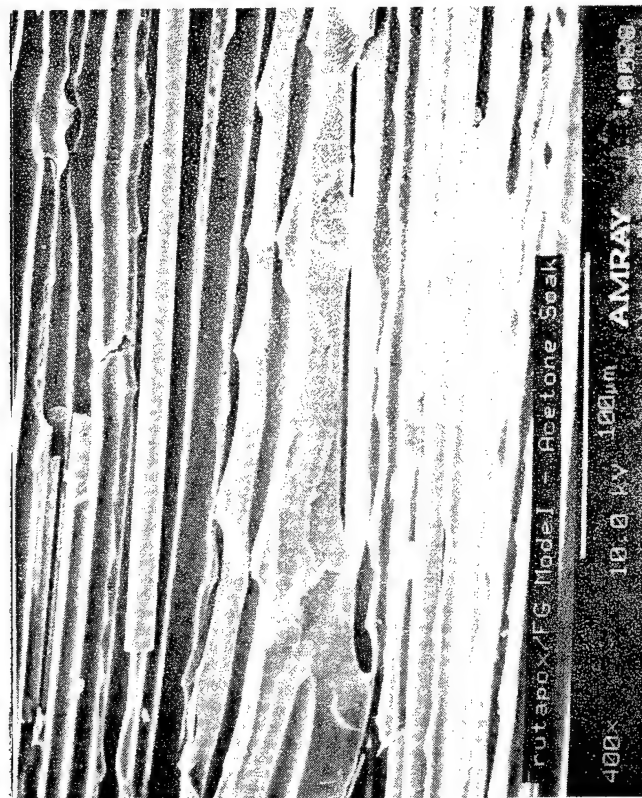
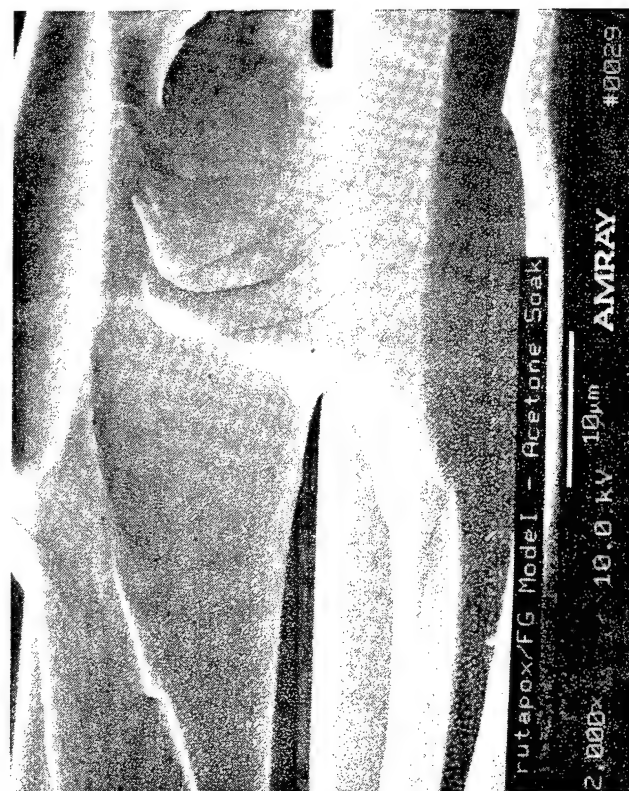
Figure 3.6-14. SEM Fractographs of a Rutapox/FG Fabric Interlaminar Mode I (Tensile) Fracture Surface Exposed to Acetone for 7 days

For the Rutapox epoxy resin system, only four specimens were examined that were of the most severe environments; JP4, Acetone, MEK, and Hydraulic Fluid (Figure 3.6-14 through 3.6-16). Examination of the fracture surfaces revealed no degradation of the fracture features regardless of the exposure conditions.

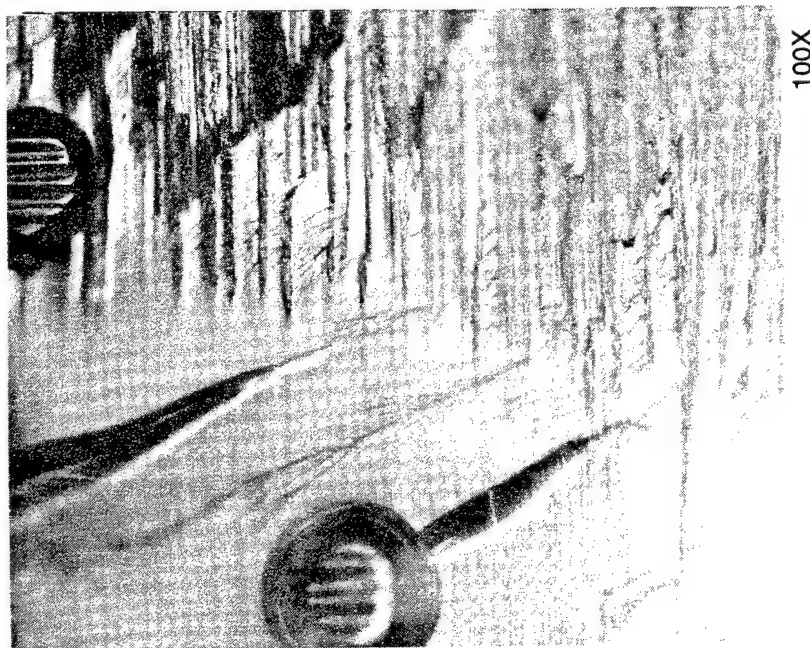
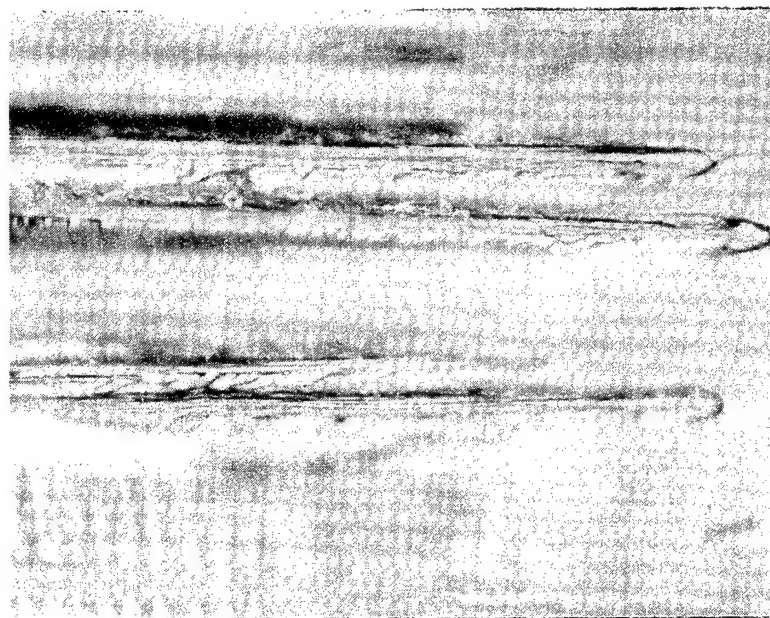
Figure 3.7-1. Optical Fractographs of a Rutapox/Graphite Fabric Interlaminar Mode I (Tensile) Fracture Surface, RT

The fracture surface (Figure 3.7-1 & 3.7-2) contained numerous resin-rich regions with voids distributed throughout the surface. These voids were likely the result of panel processing rather than a specific material attribute. This resulted in an overall shiny appearance when examined visually. SEM examination (Figure 3.7-1) revealed numerous rivermarks in the resin-rich regions indicating the crack growth direction. The resin between the fibers perpendicular to the fracture direction was composed of hackles with no specific discernible fracture direction.

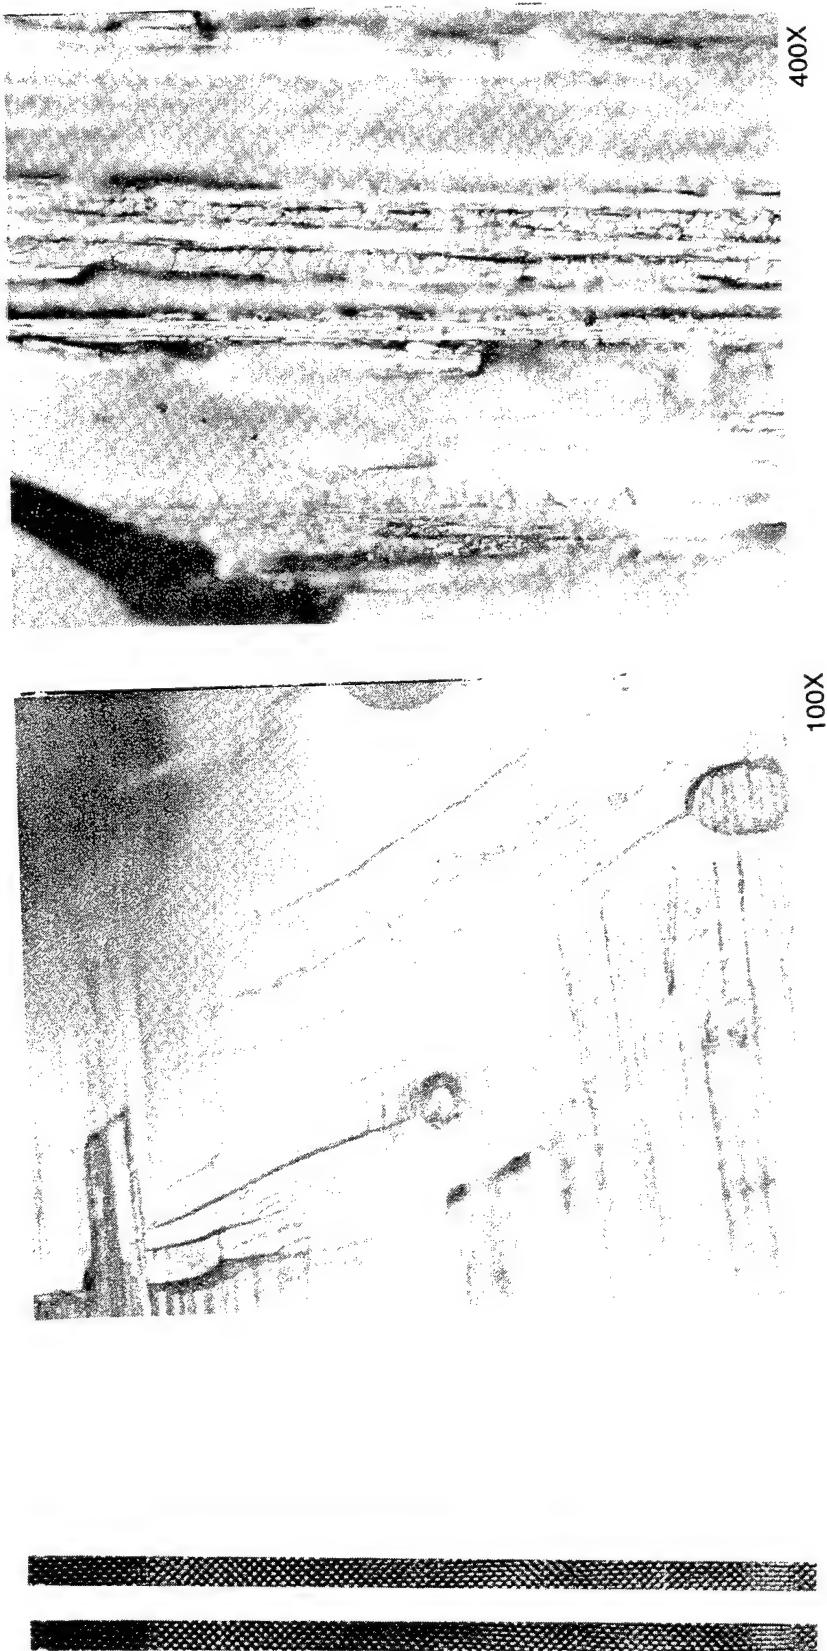
Figure 3.7-3. Optical Fractographs of a Rutapox/Graphite Fabric Interlaminar Mode I (Tensile) High-Rate Fracture Surface, RT

The high strain rate specimen fracture surfaces (Figure 3.7-3 & 3.7-4) were similar to the normal rate specimens, but the river patterns were more evident.

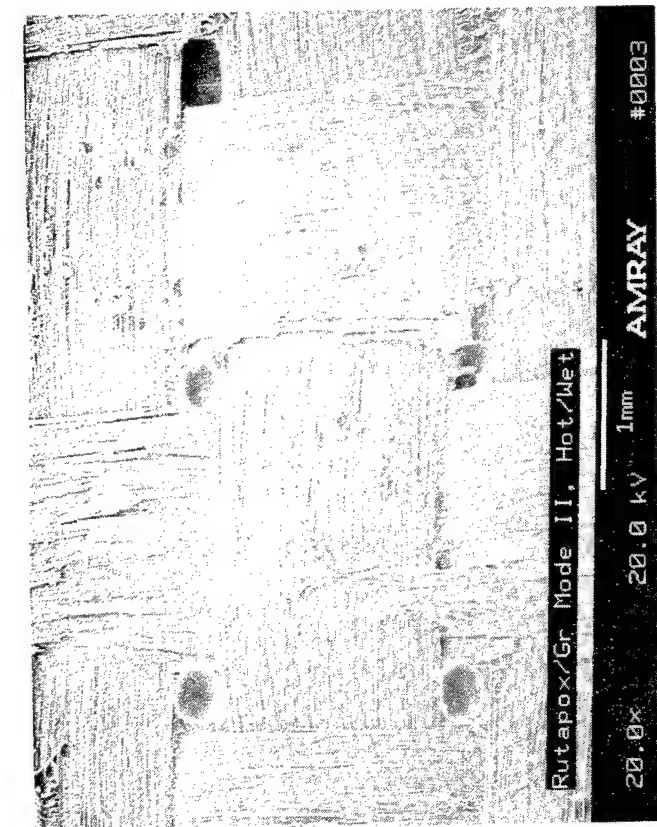
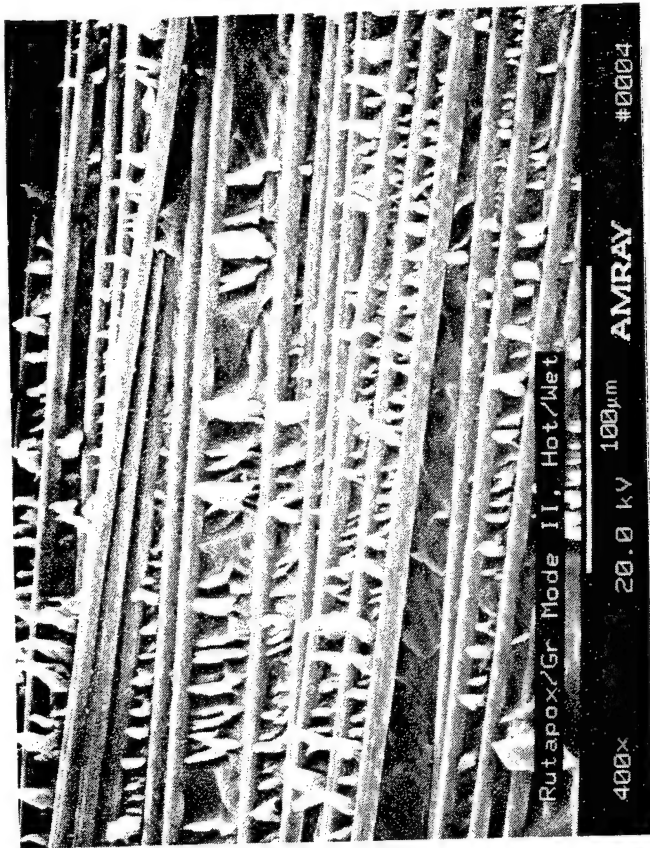
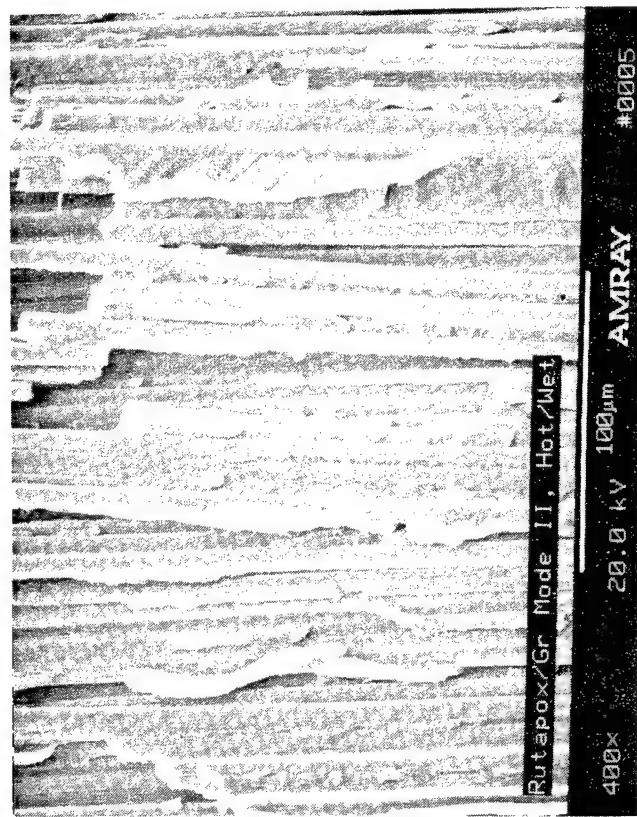
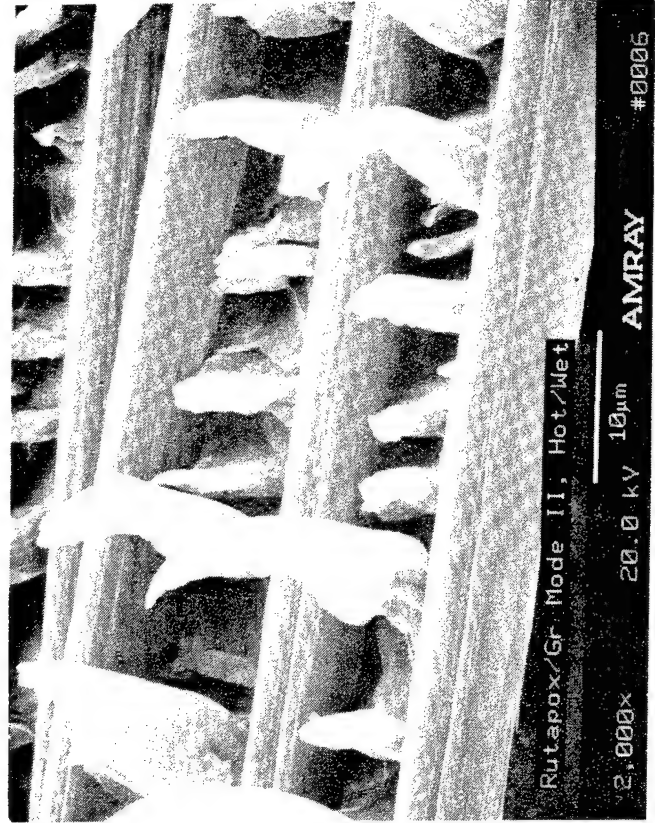
Figure 3.7-6. SEM Fractographs of a Rutapox/Graphite Fabric Interlaminar Mode II (Shear) Hot/Wet Fracture Surface, RT

The fracture surface of the RT/dry specimen was composed mainly of resin which indicates that the crack propagated through the interface between the fabric surface (as seen in the Hot/Wet fractographs) and

the resin. This resin fracture surface also contained translaminar cracks, perpendicular to the fibers, which are typical of shear cracked resin surfaces. In addition, voids were also present at the fabric tow intersections.

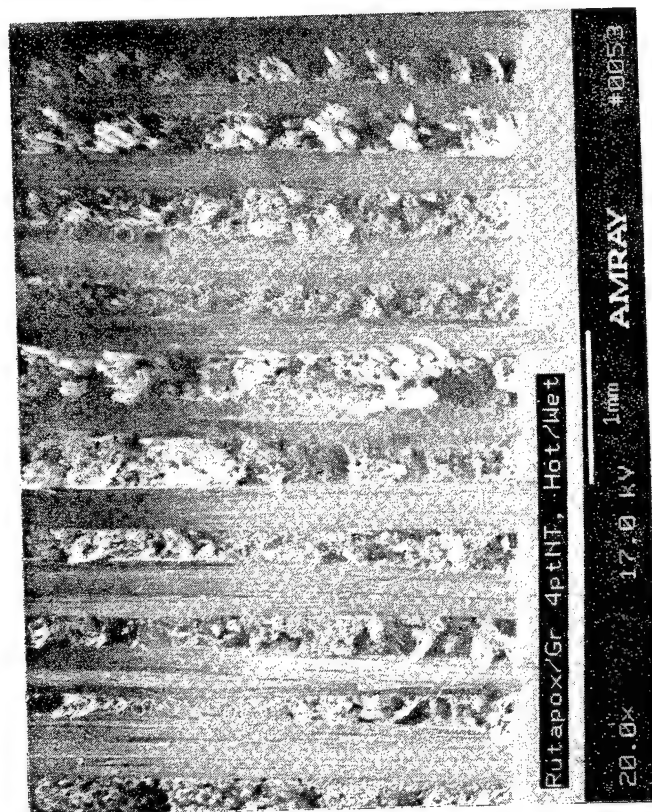
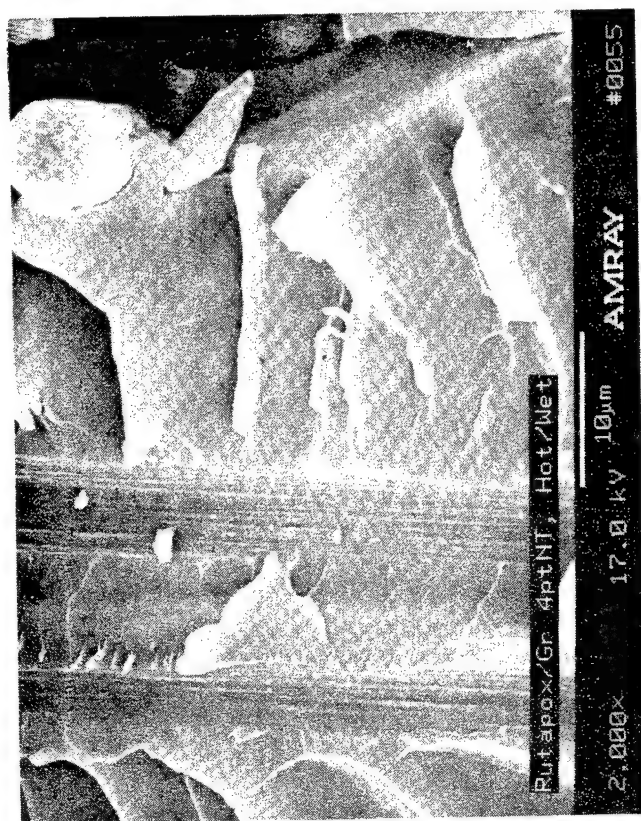
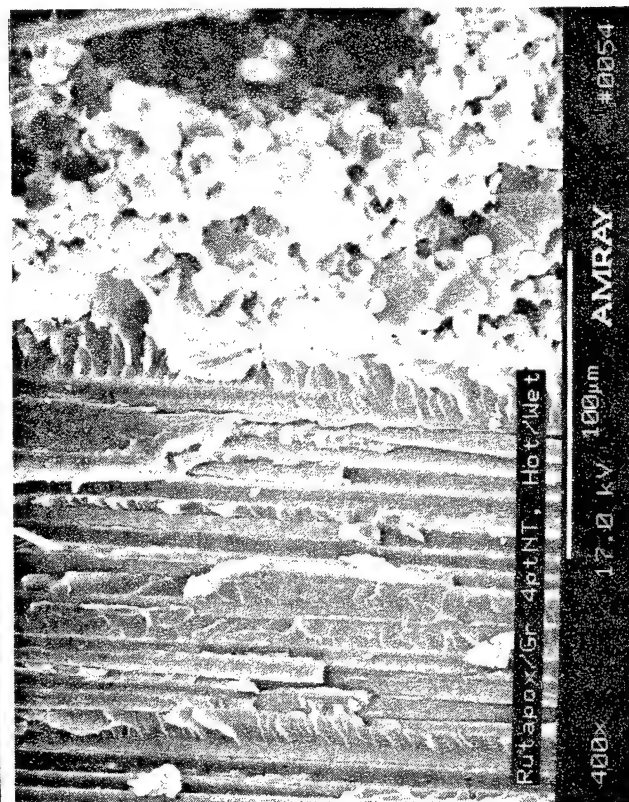
Figure 3.7-7. SEM Fractographs of a Rutapox/Graphite Roving 4ptNT Fracture Surface, Hot/Wet

Both fracture surfaces (Figures 3.7-7 & 3.7-8) were similar and both contained slightly oval fibers with longitudinal striations. There was little correlation between the fiber end fractures and the macroscopic fracture direction. In addition, even there was fairly good wetting of the fibers by the resin, it was difficult to determine the fracture direction on the ply surfaces parallel the fracture direction. Few fracture morphology features were evident on these surfaces.

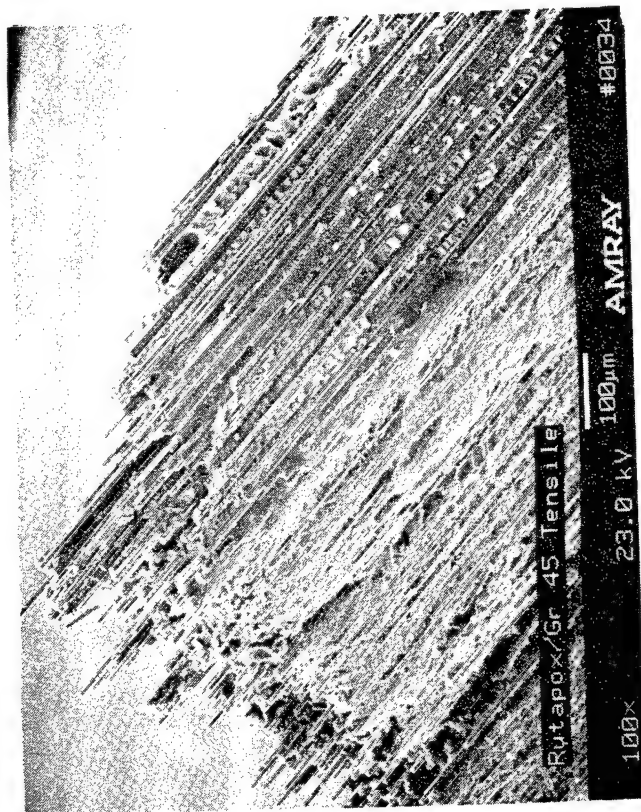
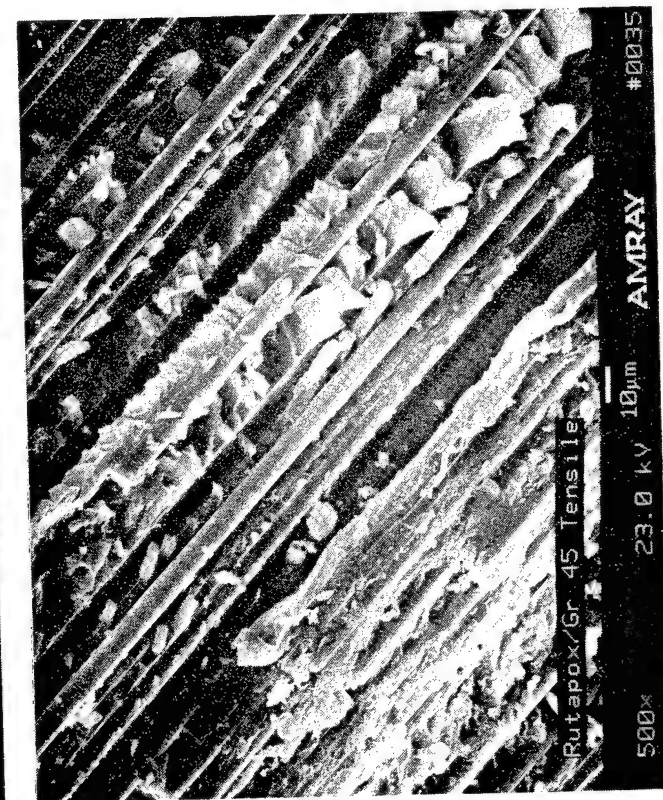
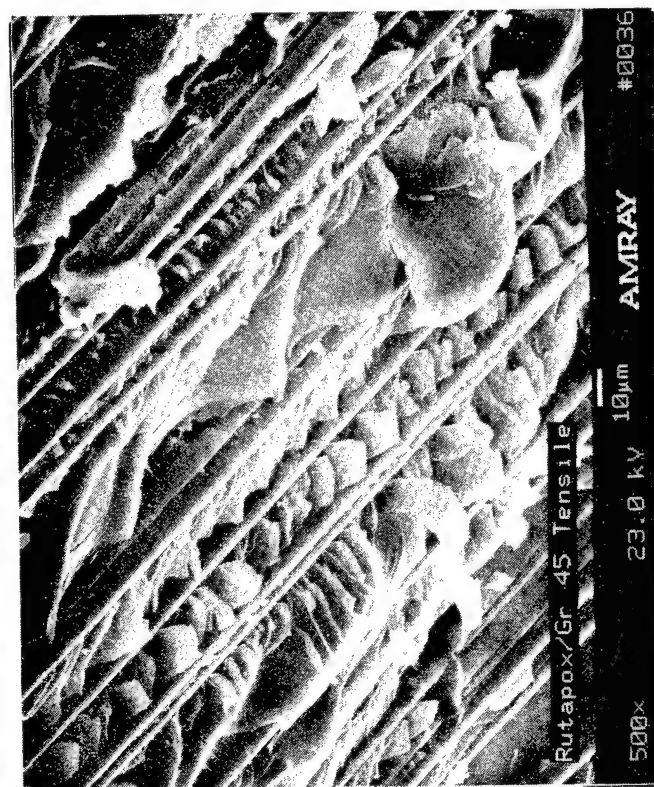
Figure 3.7-9. SEM Fractographs of a Rutapox/Graphite Fabric  $\pm 45^\circ$  Tensile Fracture Surface, RT

The overall appearance of the fabric surface exhibited both mode I and II fractures features (Figure 3.7-9). The orientation of the hackles did not give an obvious indication of the overall crack propagation direction.

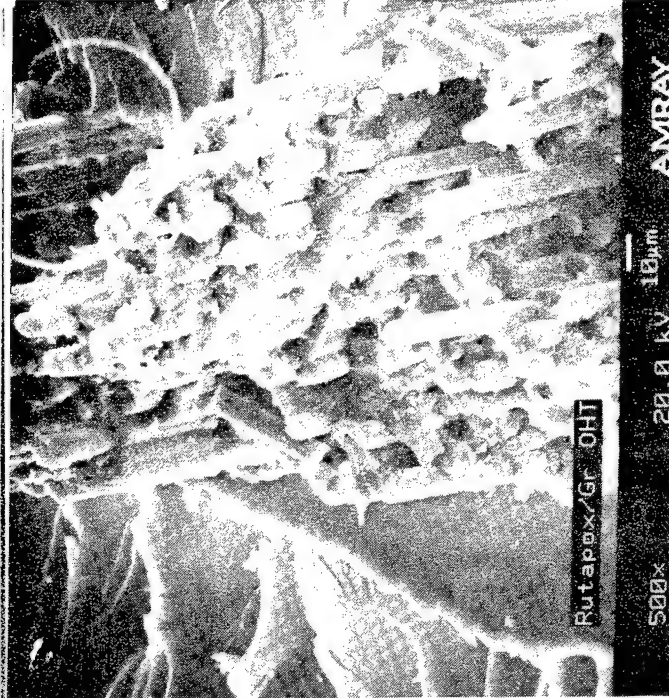
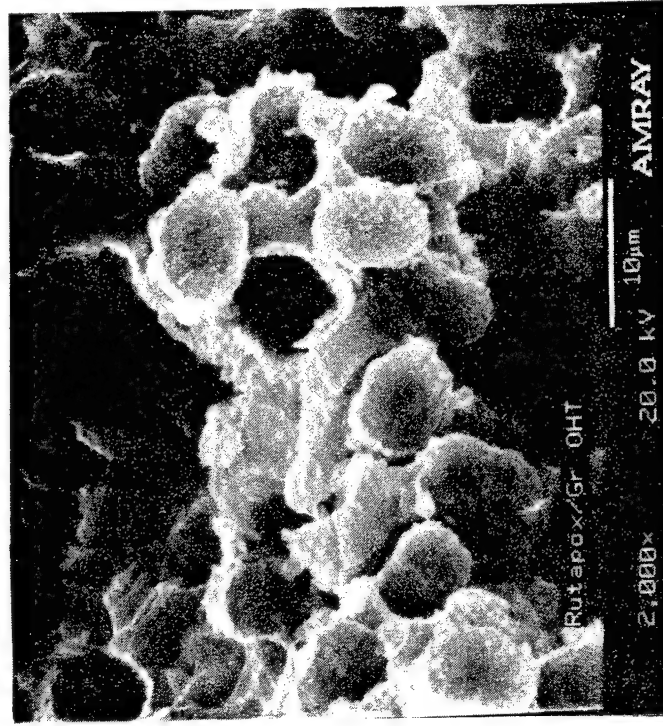
Figure 3.7-10. SEM Fractographs of a Rutapox/Graphite Fabric Open Hole Tension Fracture Surface, RT

The fiber ends did not clearly indicate the overall crack direction from examination of a small sample (Figure 3.7-10). The fibers were oval and contained distinct longitudinal ridges. Tracer yarns in the fabric were clearly visible and were initially confused with some type of fiber pull-out condition. The plies parallel to the crack direction had hackles on the surfaces, but it generally appeared that these tow regions were pulled apart in a mode I.

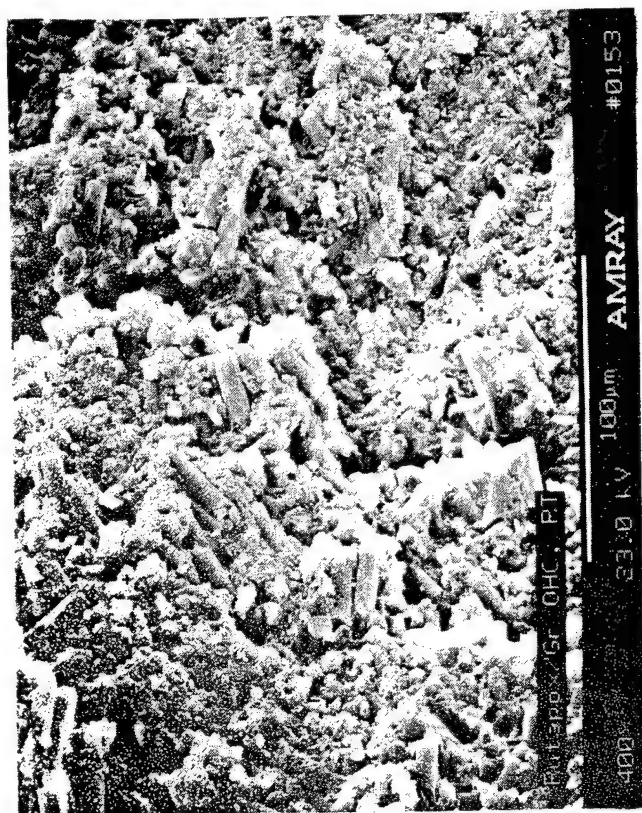
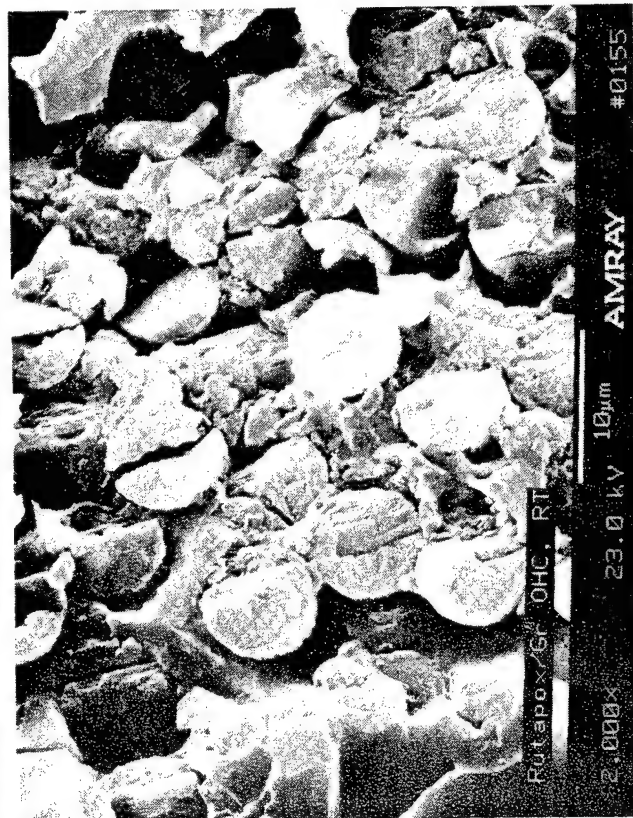
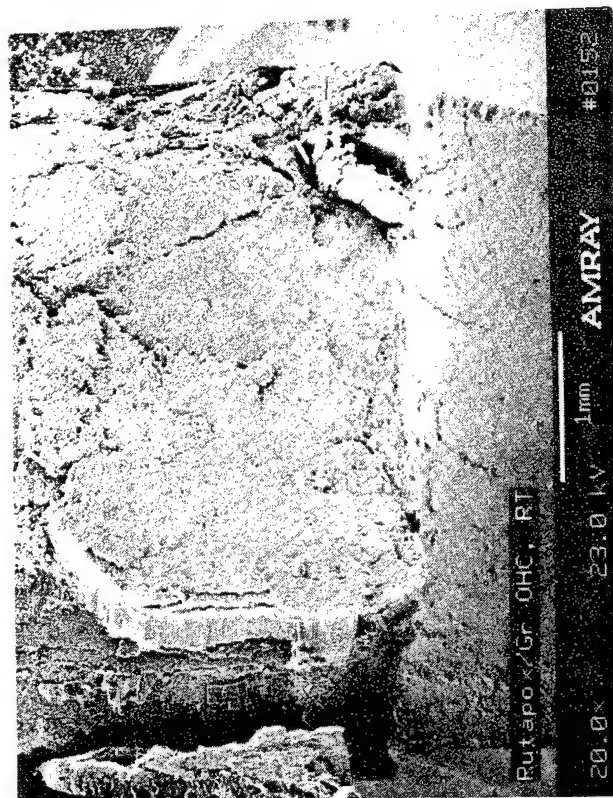
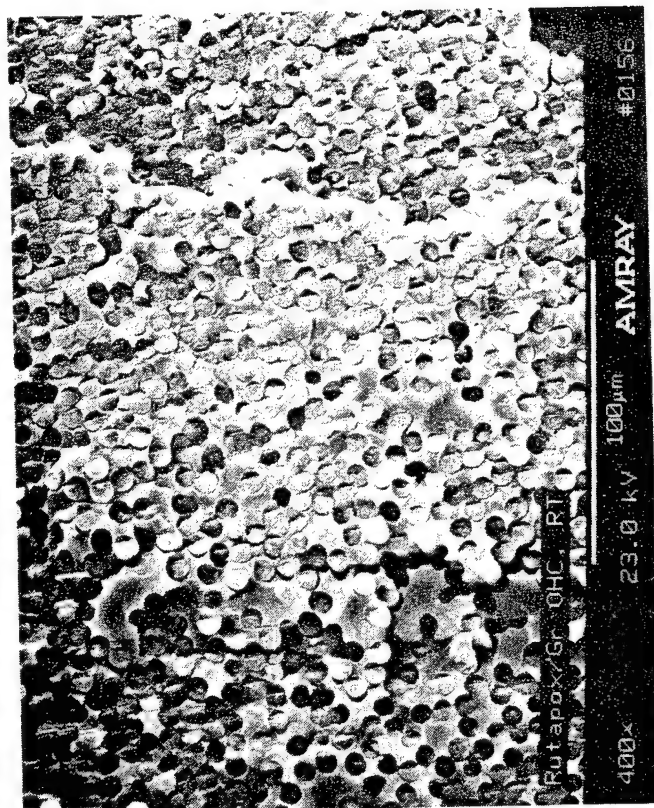
Figure 3.7-11. SEM Fractographs of a Rutapox/Graphite Rovings Open Hole Compression Fracture Surface, RT

Two distinct regions were present on the fracture surfaces (Figure 3.7-11). The region adjacent to the hole contained a great deal of rubble covered with small sections of fractured fibers. The regions further away from the hole exhibited the classic compression fracture morphology with the distinct centerline through the fibers. In addition, some of the fibers were actually split along their centerline to an unknown depth.

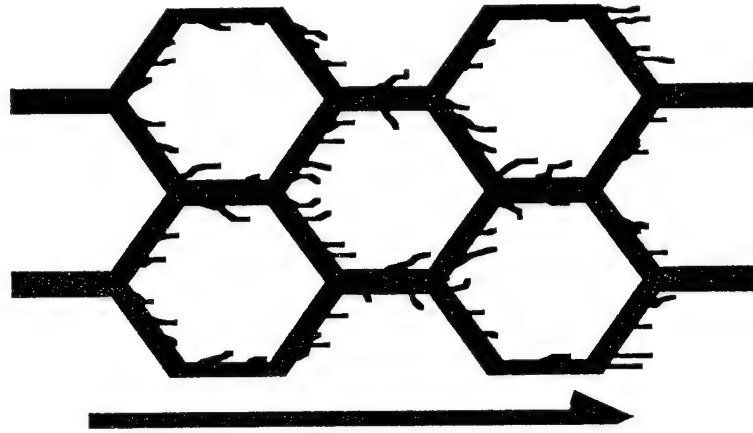
Figure 3.8-1. *Fibers Torn and Bent in the Direction of the Propagation of the Failure*

Failure propagation in honeycomb material is best determined by examination of the fiber pullout and by the direction in which the fiber is bent. As the honeycomb fails, the fiber and resin fail separately. The fiber is often freed from the resin by the failure and is drawn plastically in the direction of the displacement due to the propagation of the failure. For tensile failure this displacement is nearly normal to the direction of propagation, with a slight bias in the direction of propagation. The bias can result in plastic deformation of the side of the fiber away from the propagation direction or breakage of the fiber with the propagation direction of the crack in the fiber the same as that in the honeycomb. The result of these effects is that the propagation direction is indicated by the lay of the loose ends of fibers along the failed surface (see Figure 3.8-1). Studying the crack propagation directions in the resin meniscus where the honeycomb ribbons join is a more difficult method of determining the failure propagation direction.

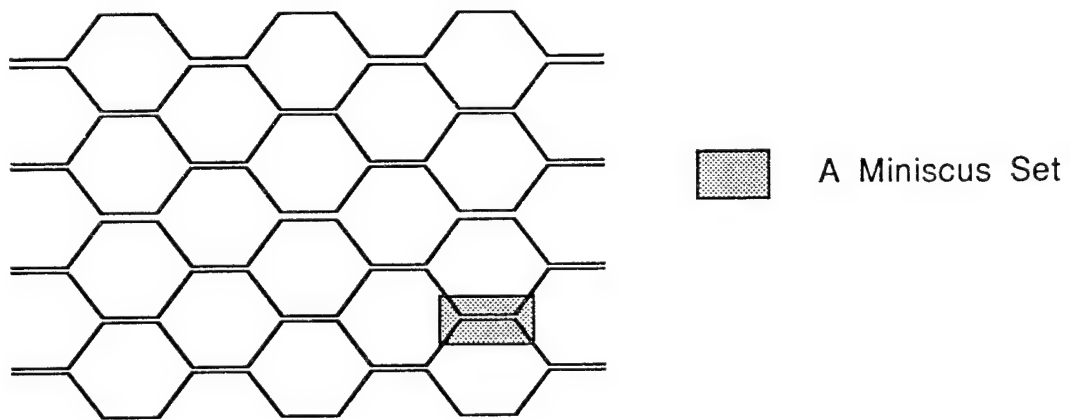
Figure 3.8-2. *Orientation of the Continuous Ribbons in the Honeycomb Denoting the Ribbon Direction and the Associated Miniscus Set*

The locations where the ribbons join have a double ribbon thickness and additional resin to strengthen that location (see Figure 3.8-2). The resin meniscus is a trilobate structure, with its weakest points at the terminations of these lobes or arms, which are directed 120 degrees from one another. In all the test specimens, the loading occurred such that propagation direction for the failure would be parallel to the ribbon direction. The failure could propagate only along one of three paths. Two of these paths were along single plies of ribbon oriented at 60 degrees from the line of the ribbon junctures. The other direction was that of the ribbon juncture (see Figure 3.8-3). Whenever one of these juncture areas failed, both menisci were involved. If the failure was the result of a traveling failure front, then one of the menisci broke from the juncture outward (the trailing meniscus) and one broke from one of the arms along the single-ply edge of the cell (see Figure 3.8-4). This meniscus set thereby indicates the propagation direction for that joint. The propagation direction for any one meniscus set may not be consistent with the overall direction of failure. The failure propagation

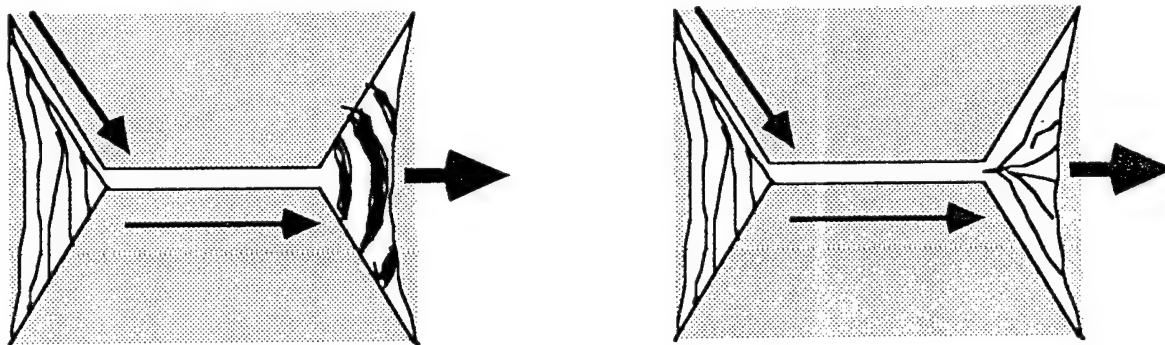
Figure 3.8-4. Failure Patterns in the Resin Menisci Indicating the Propagation Directions

The illustration on the left shows "Wallner" lines indicating the failure initiated at the apex of the upper arm of the meniscus. It then propagated across the joint and caused a conchoidal fracture in the trailing meniscus. The illustration on the right shows the same type of event but with a Wallner line failure pattern at the trailing meniscus.

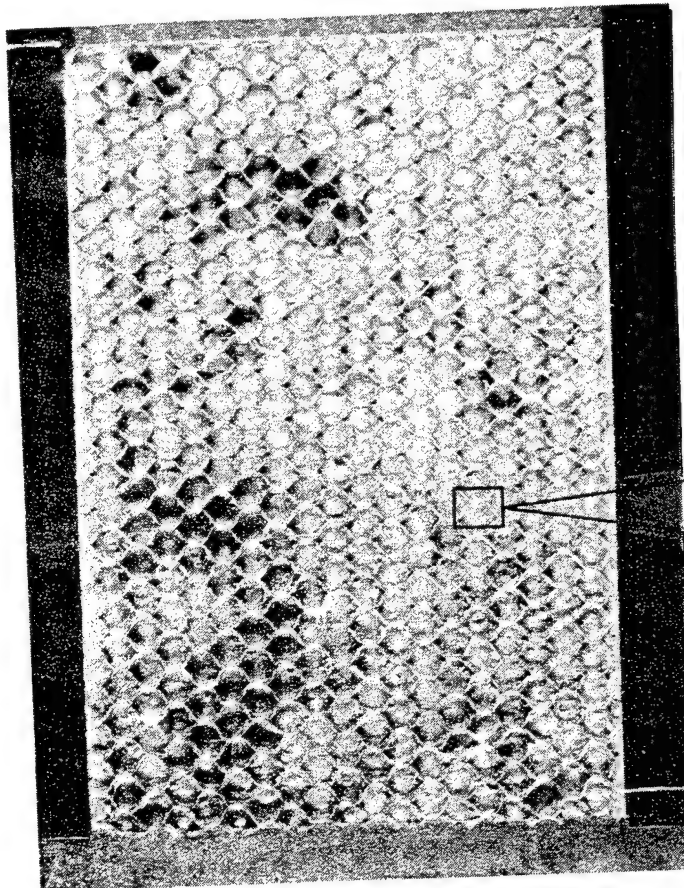
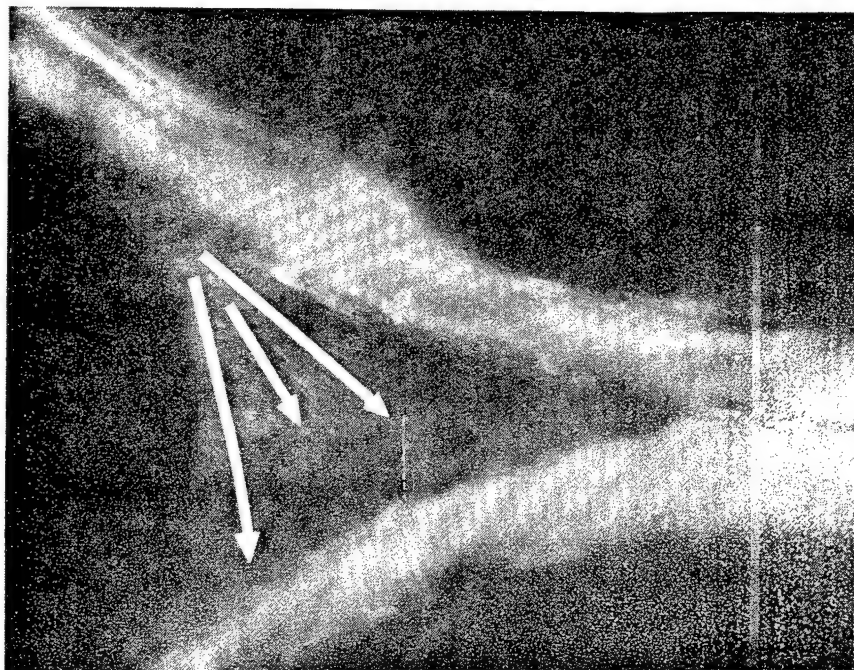
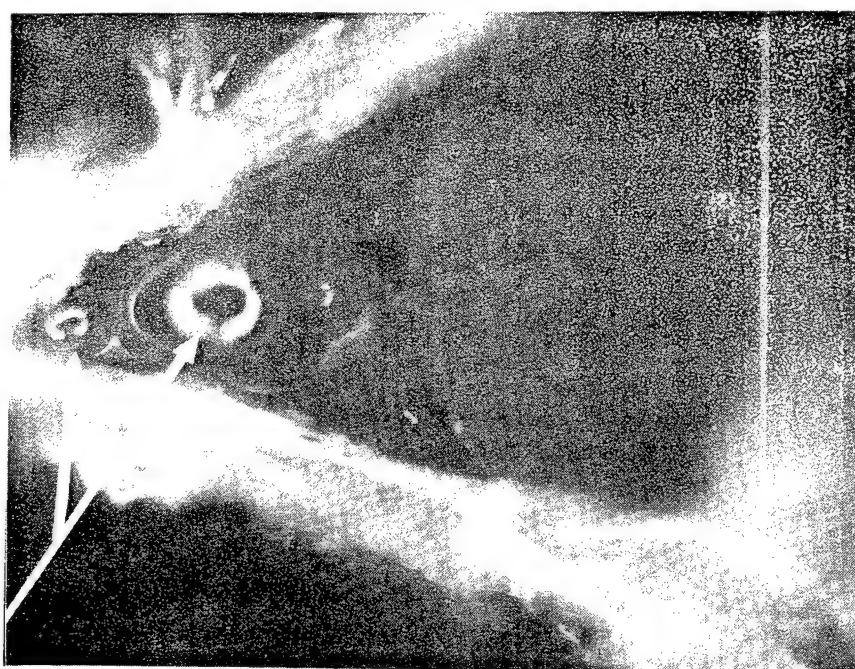
Figure 3.8-9. Optical Fractographs of Mode I Sandwich, Control Specimen  
Sheet 1 of 2

**Control Specimen.** No adhesive or cohesive failures were seen in these specimen types. As shown in Figure 3.8-9, 100% core failure was observed.

Bubbles

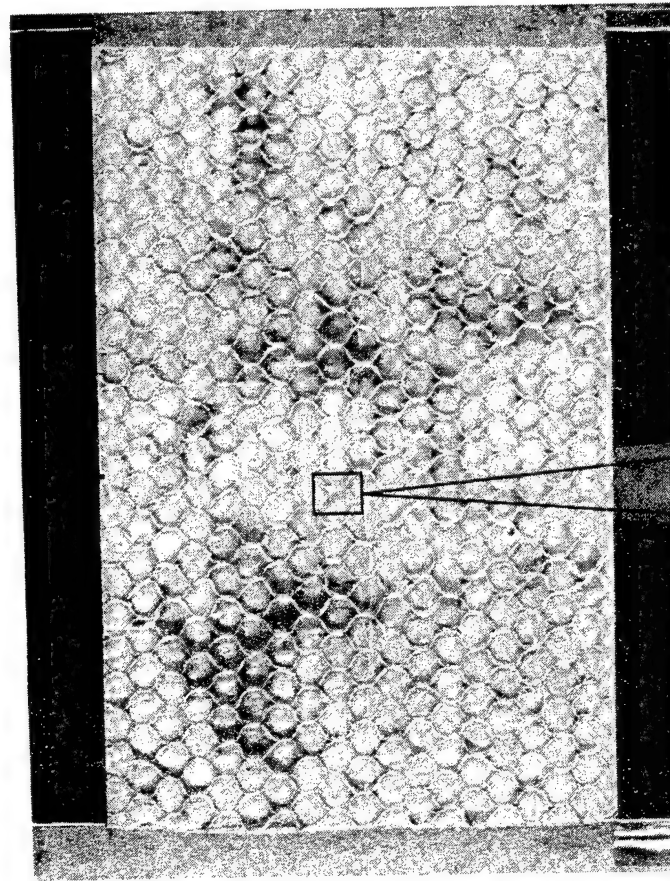
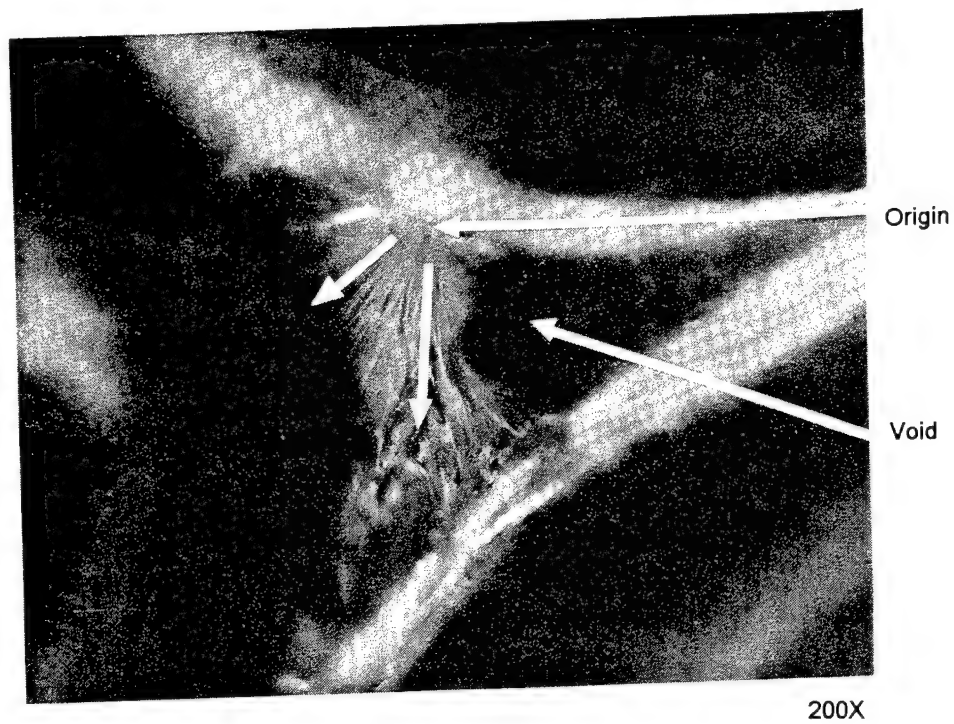
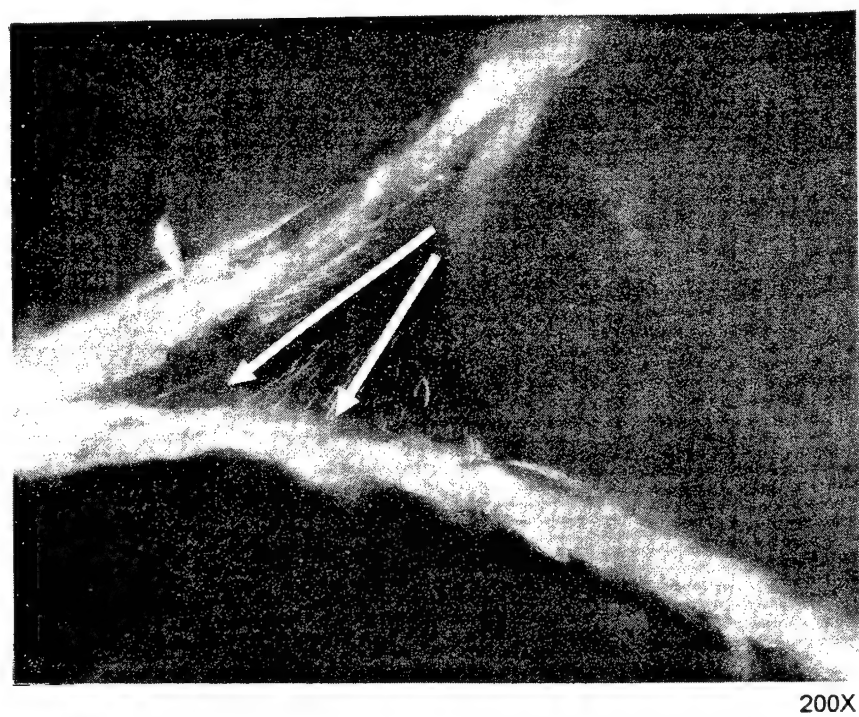
*Figure 3.8-10. Optical Fractographs of Mode I Sandwich, Aged Adhesive Specimen  
Sheet 1 of 2*

**Aged Adhesive Specimen.** The honeycomb cells appeared to be more distorted in these specimens than in the others. It has not been determined if this is the result of processing or testing. The amount of burst fibers was less than that seen in the control specimen. As shown in Figure 3.8-10, the failure was in the honeycomb.
